Manhole Inspection Summary

Manhole # S25AA1012MH

Insp Date: **1/30/07 10:35 AM**

Location Address: **1131 36TH ST**

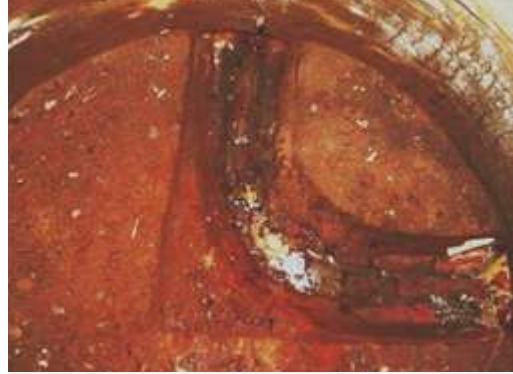
Top View

Bench and Channel debris.

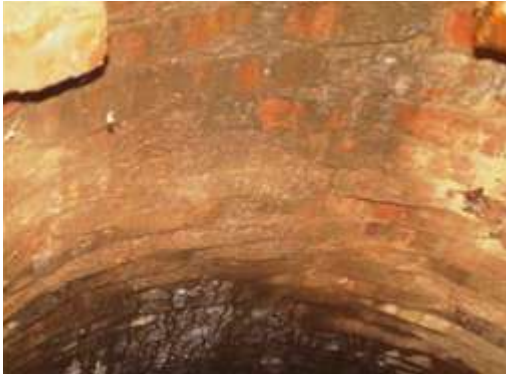
Defect

Condition: ☐ Sound ☐ Cracked ☐ Root Intrusion ☒ **Loose Brick** ☐ Deteriorated

Infiltration: ☐ None ☒ **Joint** ☐ Cracks ☐ Mortar ☐ Roots ☒ **Wall**

Infiltration: ☐ None ☐ Joint ☐ Cracks ☒ **Mortar** ☐ Roots ☒ **Wall**

Adjustment loose brick and infiltration.
Barrel infiltration.

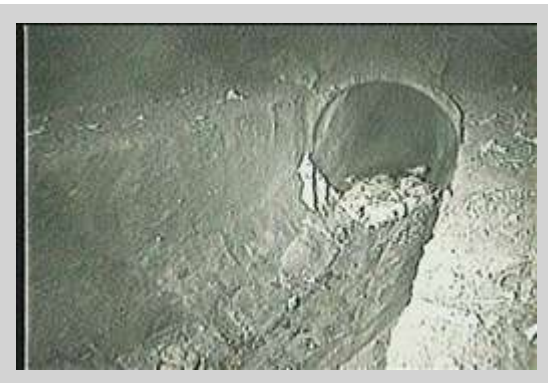
8 in. Circular Gravity Sewer Pipe In @ 3 O'Clock

Deposits: ☐ None ☐ Mud ☐ Sludge ☒ **Debris** ☐ Grease

Silt Depth: **1** (in.) Deposits Extent: **Light**

Infiltration: **None** Pipe Seal Cond: **Cracked**
